Tim Denison, Environmental Scientist
Johnson Engineering

Lake June in Winter Water Quality Assessment

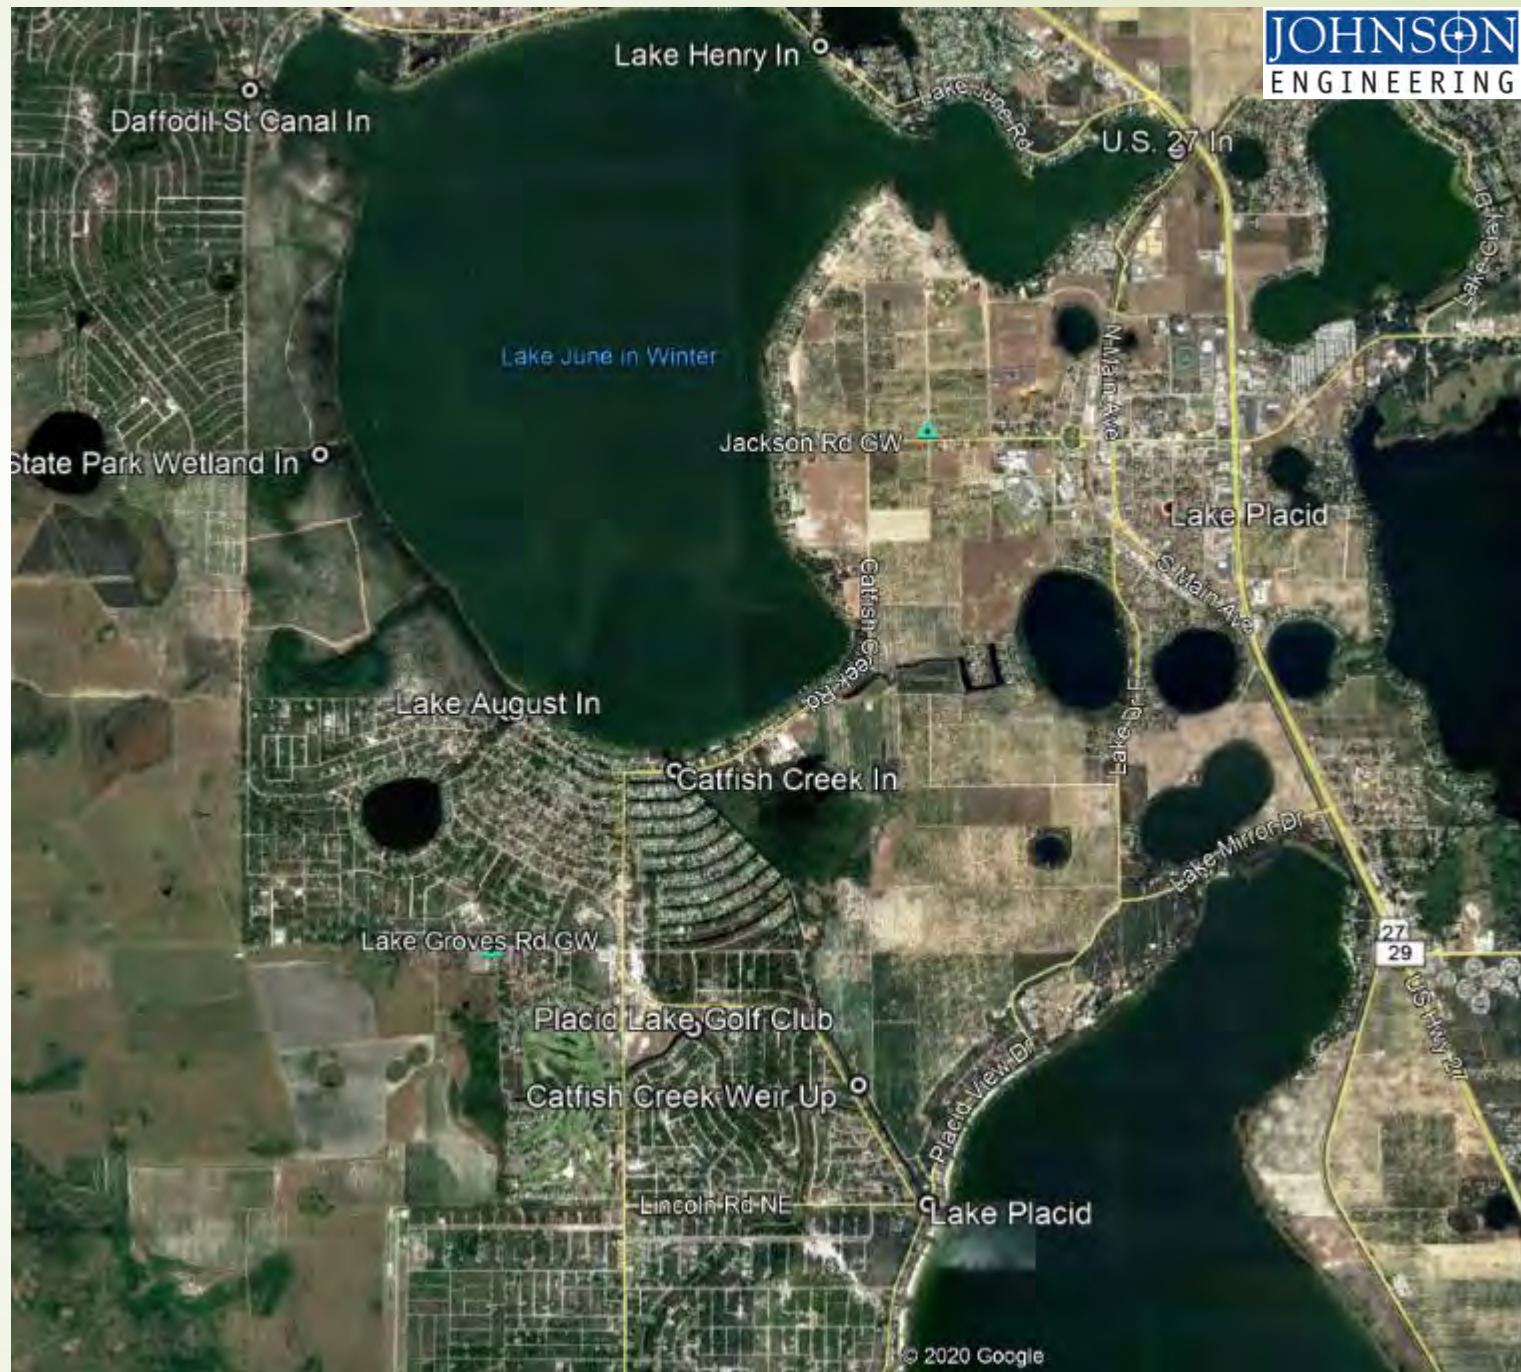
Lake June inflow

- Lake Henry and US27 to the Northeast
- Agricultural crops to the East
- Lake Placid to the Southeast
- Catfish Creek and residential areas to the South
- Lake August to the Southwest
- Scrub State Park to the West
- Daffodil Canal and residential areas to the Northwest

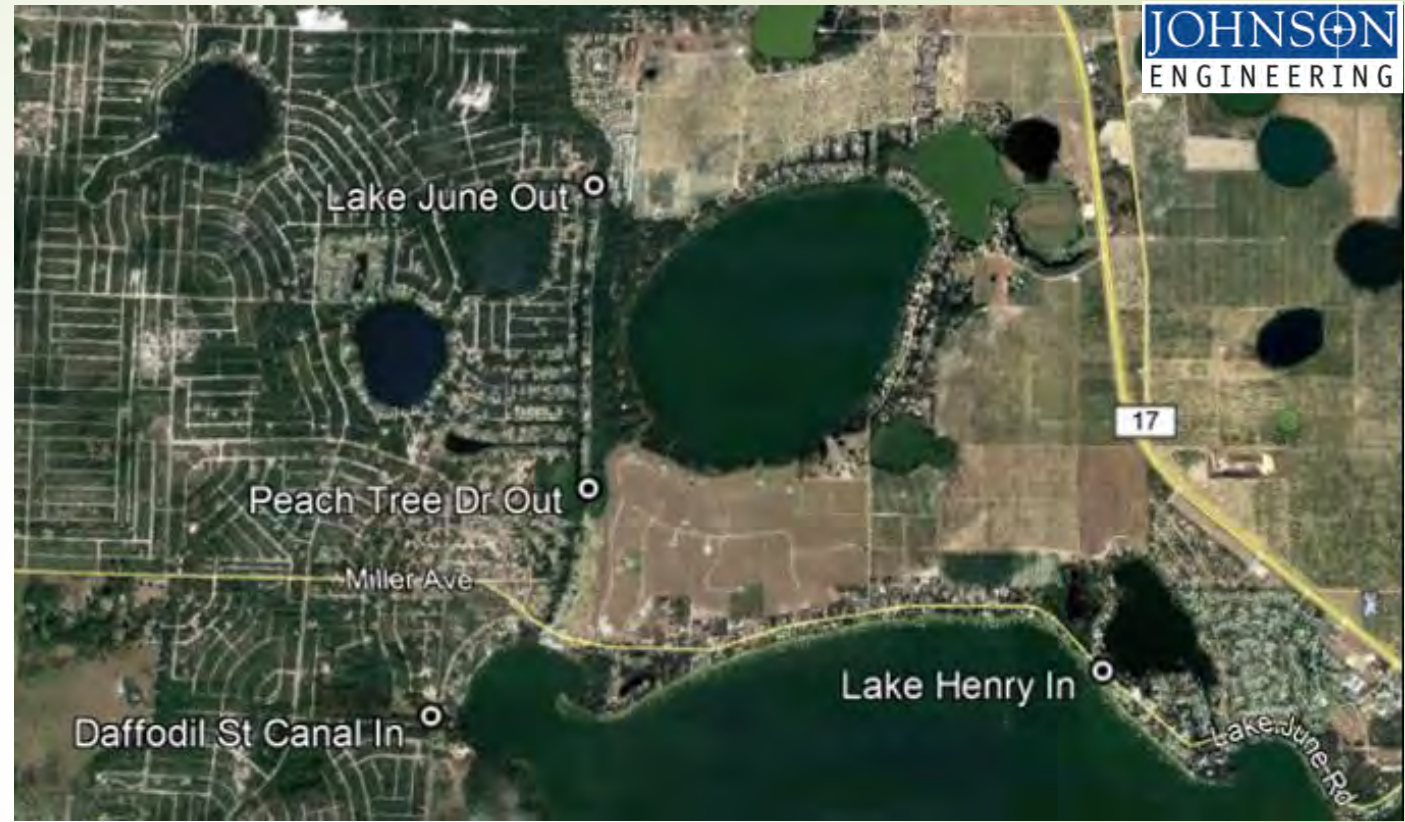
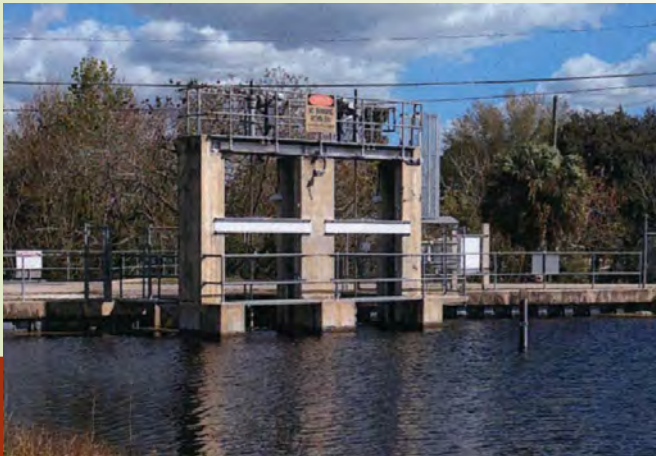
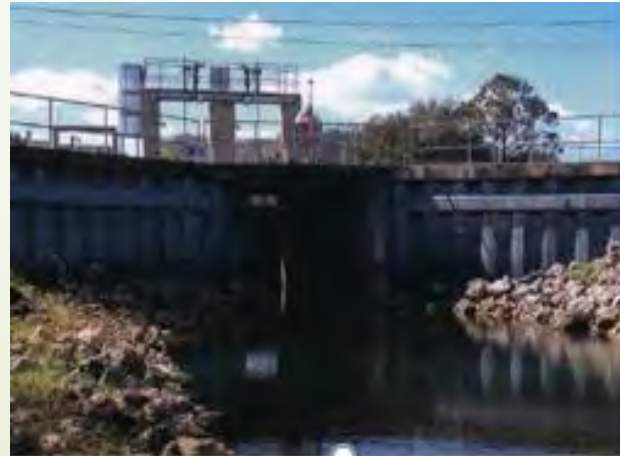
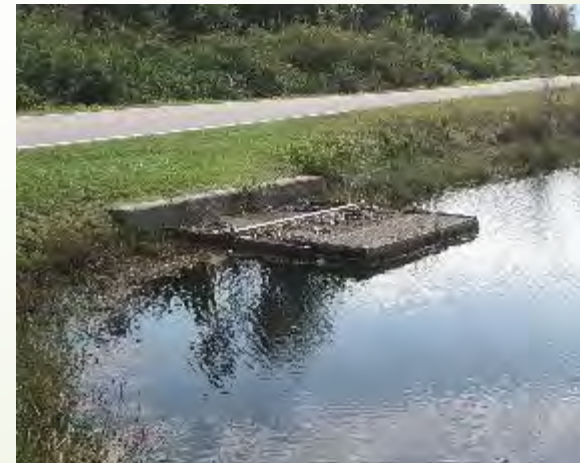
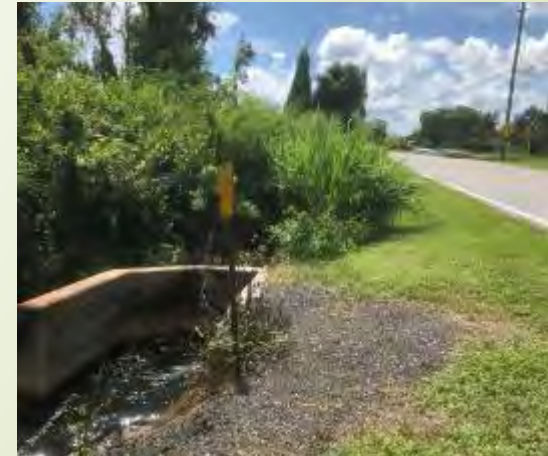
Lake June outflow

Two structures along Stearns Creek to the North

- G-90 (huge control gates)
- G-91 (small fixed weir)

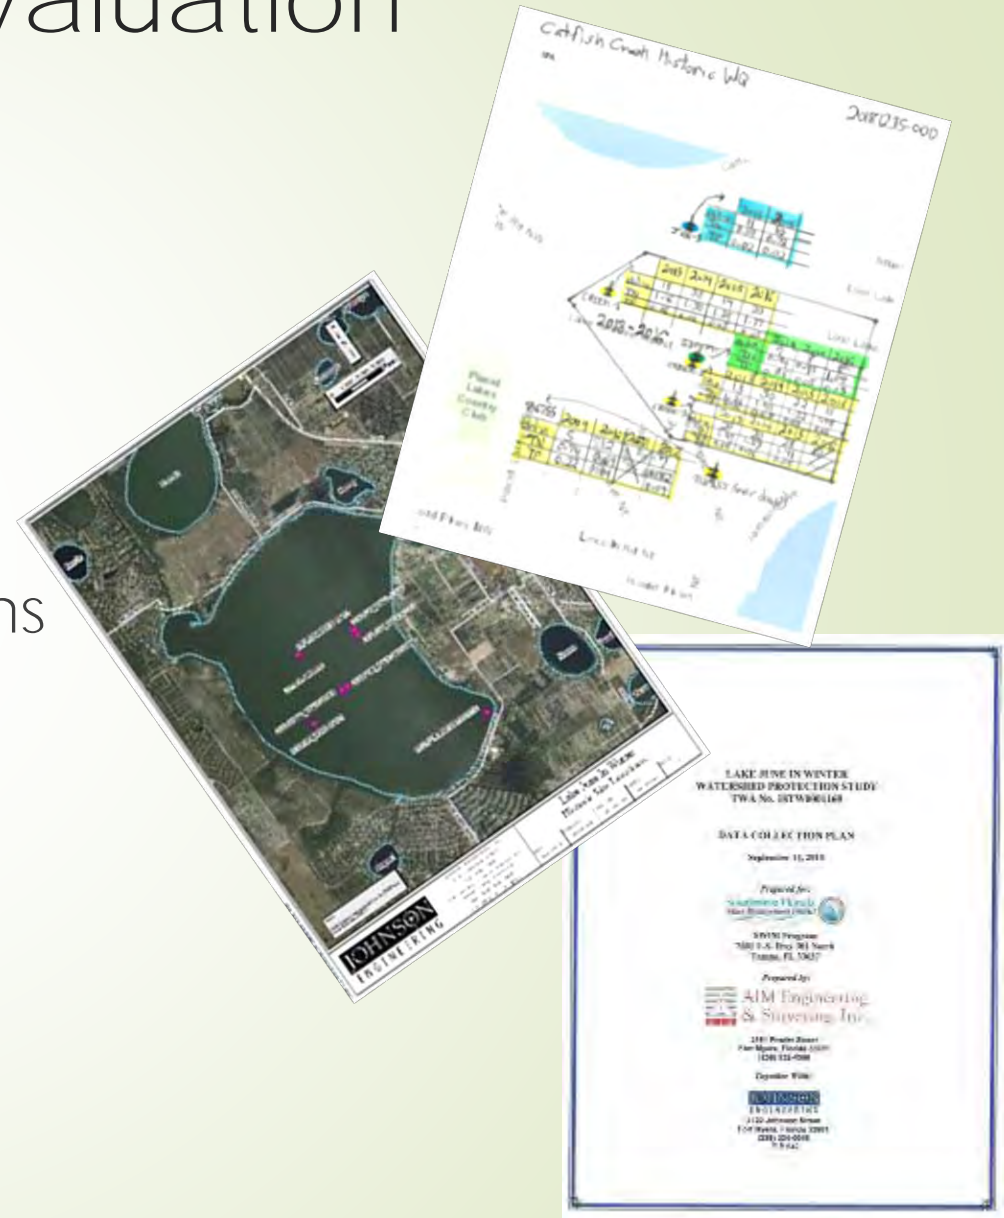
Water Quality Impact Evaluation

➤ Phased approach

1. Review historic water quality data
2. Identify existing monitoring locations
3. Develop a monitoring plan

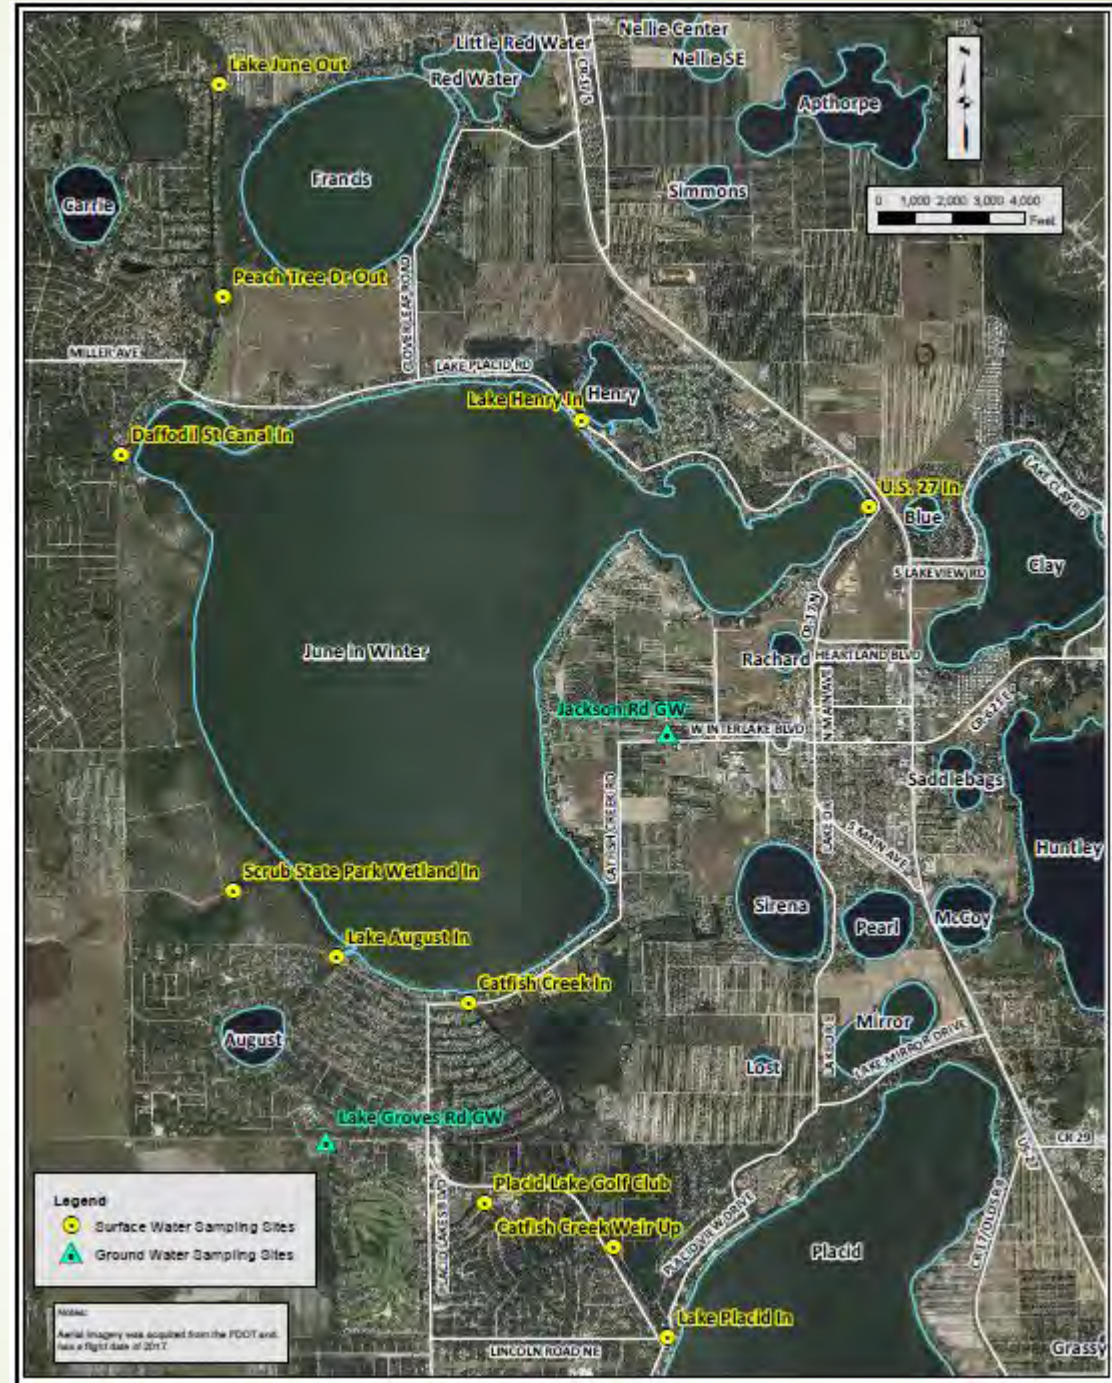
Water Monitoring Plan

- Surface Water Sampling
 - Along Catfish Creek
 - Surrounding Lake June
 - At the outfalls
- Groundwater Sampling
- Water Elevations
- Flow
- Rainfall

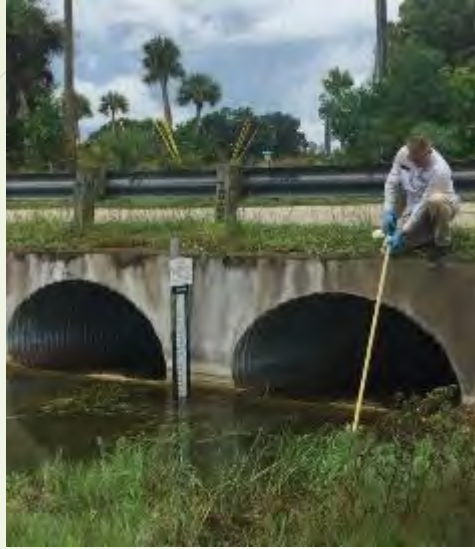
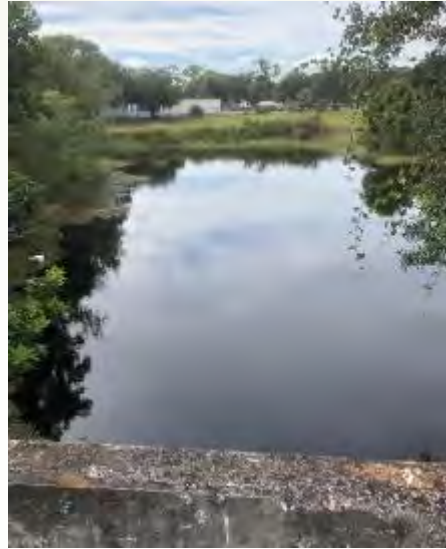
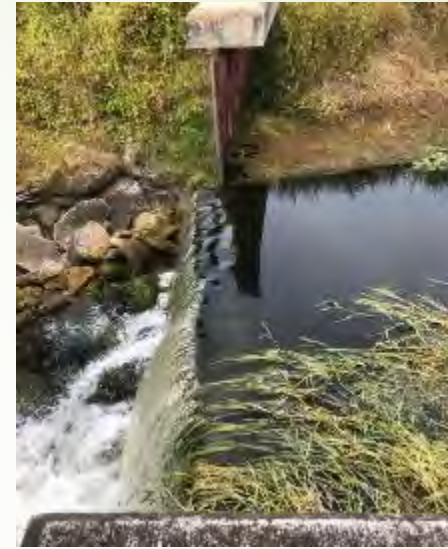
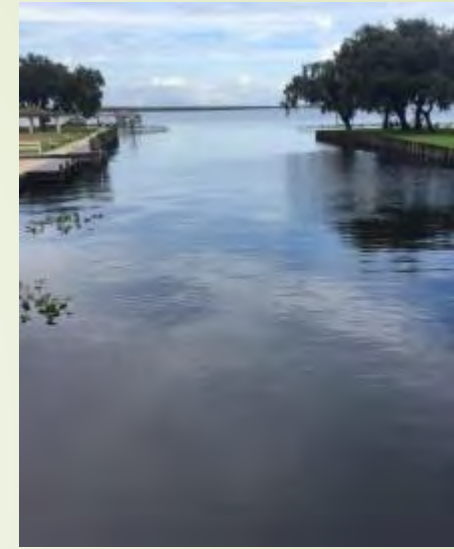
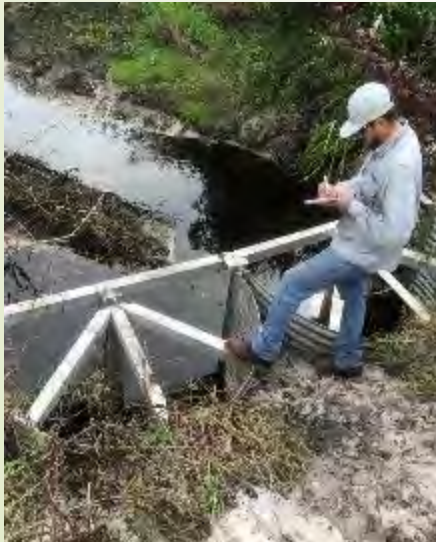
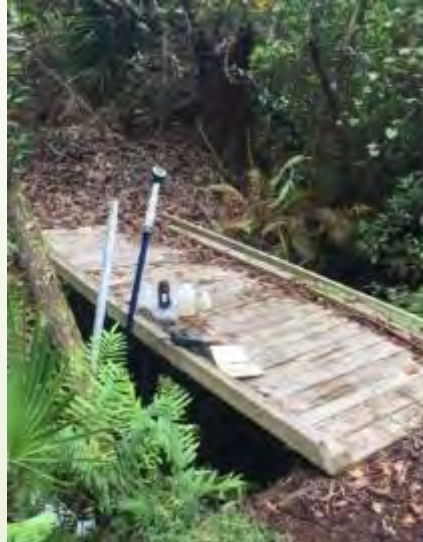
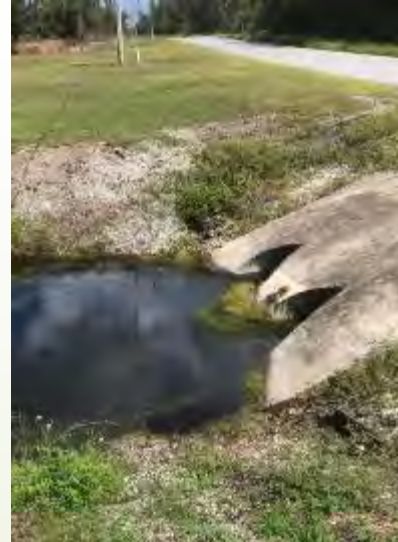
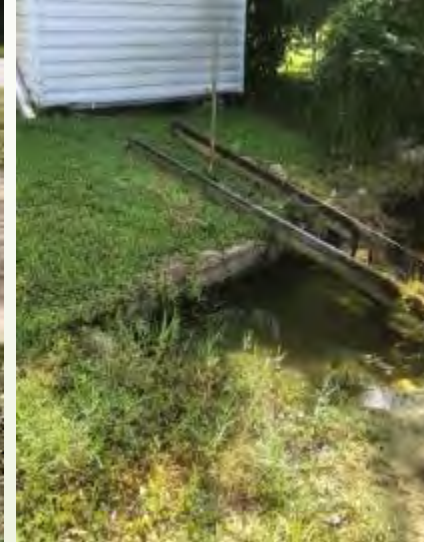
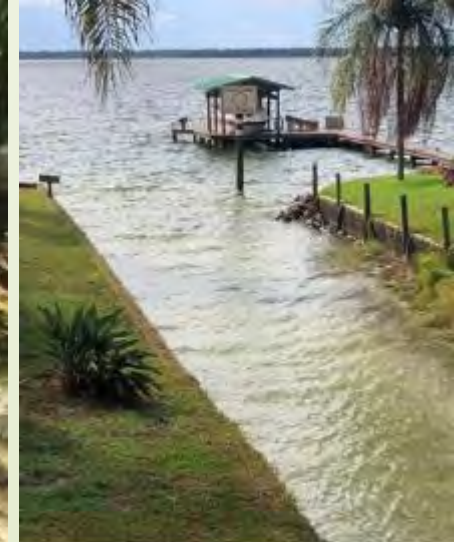
Surface Water Inflow Sampling

- Along Catfish Creek
- Around Lake June

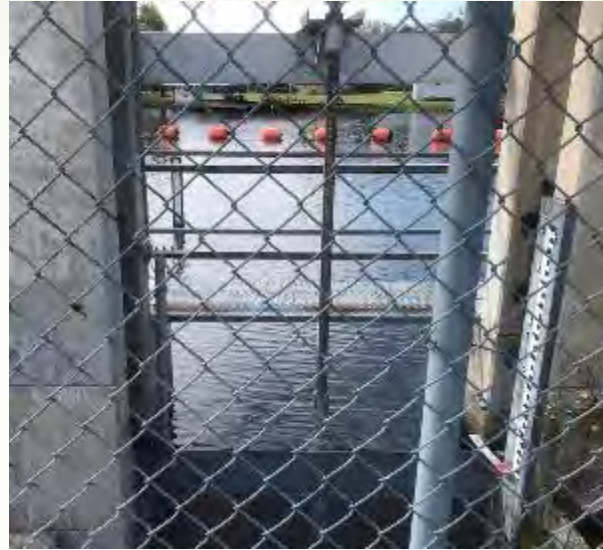
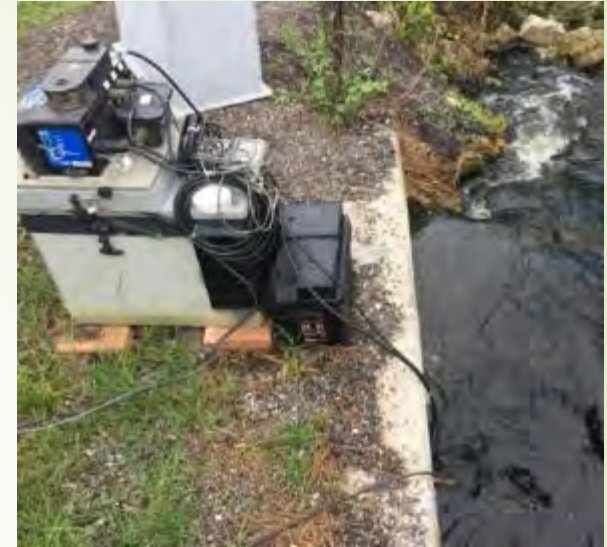
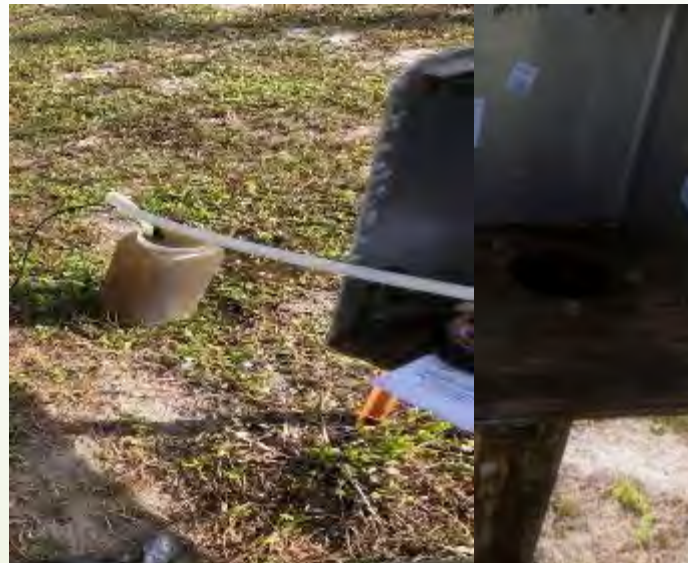
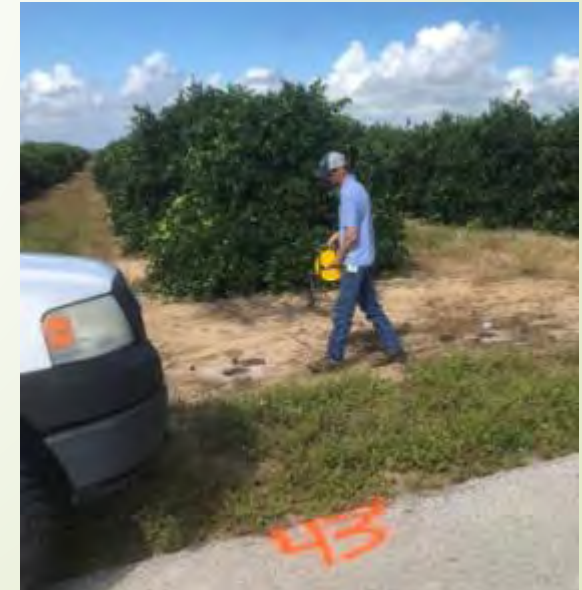
Surface Water Outflow & Groundwater Sampling

- Surface water at the outfall(s)
- Groundwater
 1. Lake Groves (near Catfish Creek)
 2. Jackson Rd (west of the lake)

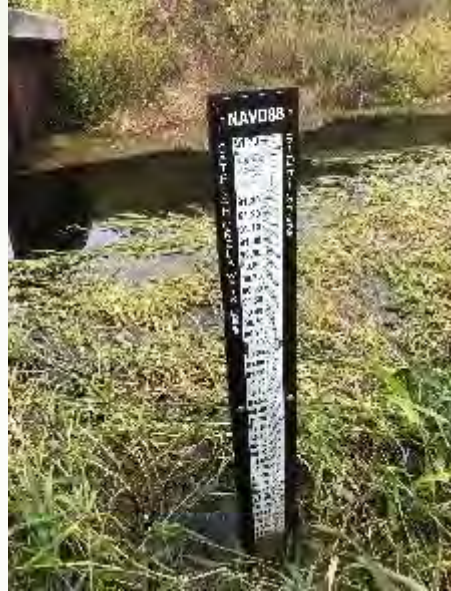
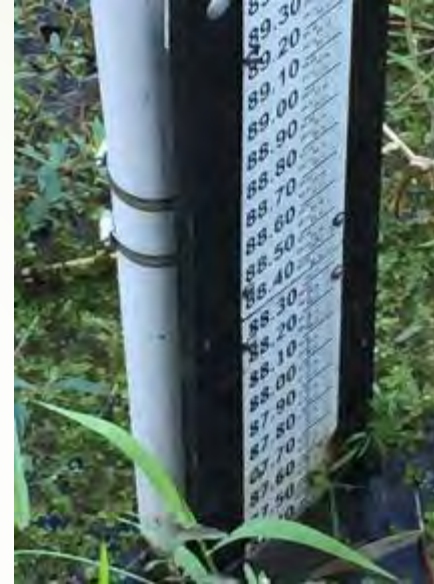
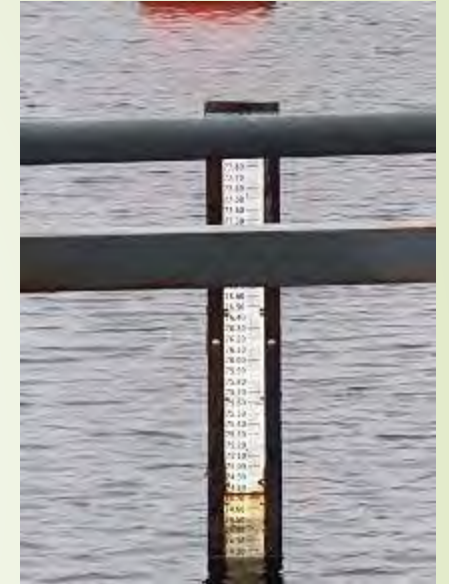
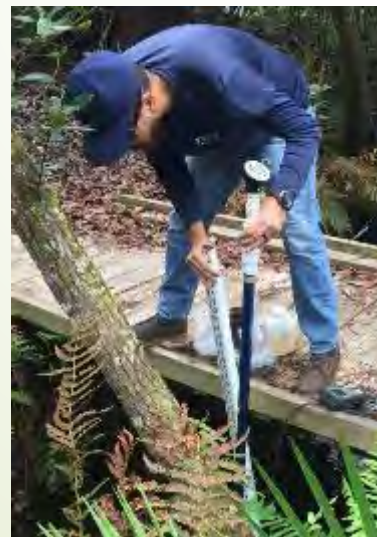
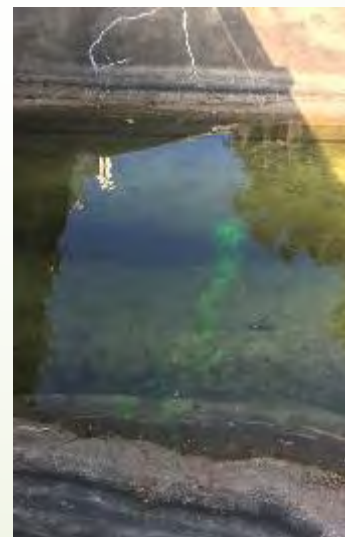
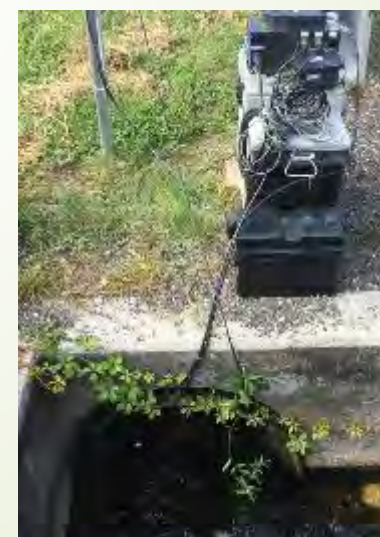
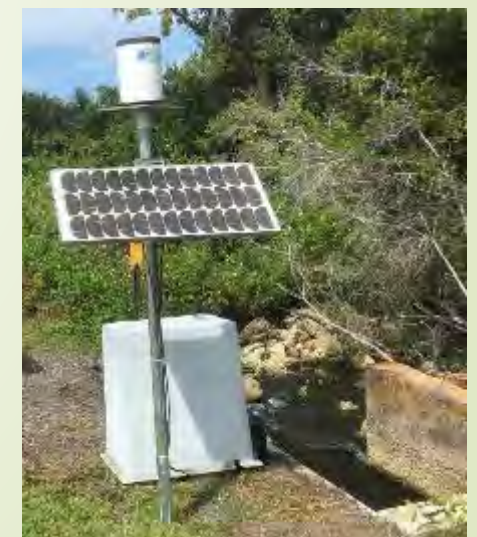
Water Elevations, Flow, and Rainfall

- Staff gauges
- Water level datalogger
- Flow probes
- Dye velocities
- Weir equations
- Doppler flowmeter
- Tipping bucket
