Innovating Shoreline Resilience: Adaptation Solutions for Florida's Coastal Communities

CUMMINS | CEDERBERG
Coastal & Marine Engineering

2025 Florida Stormwater Association

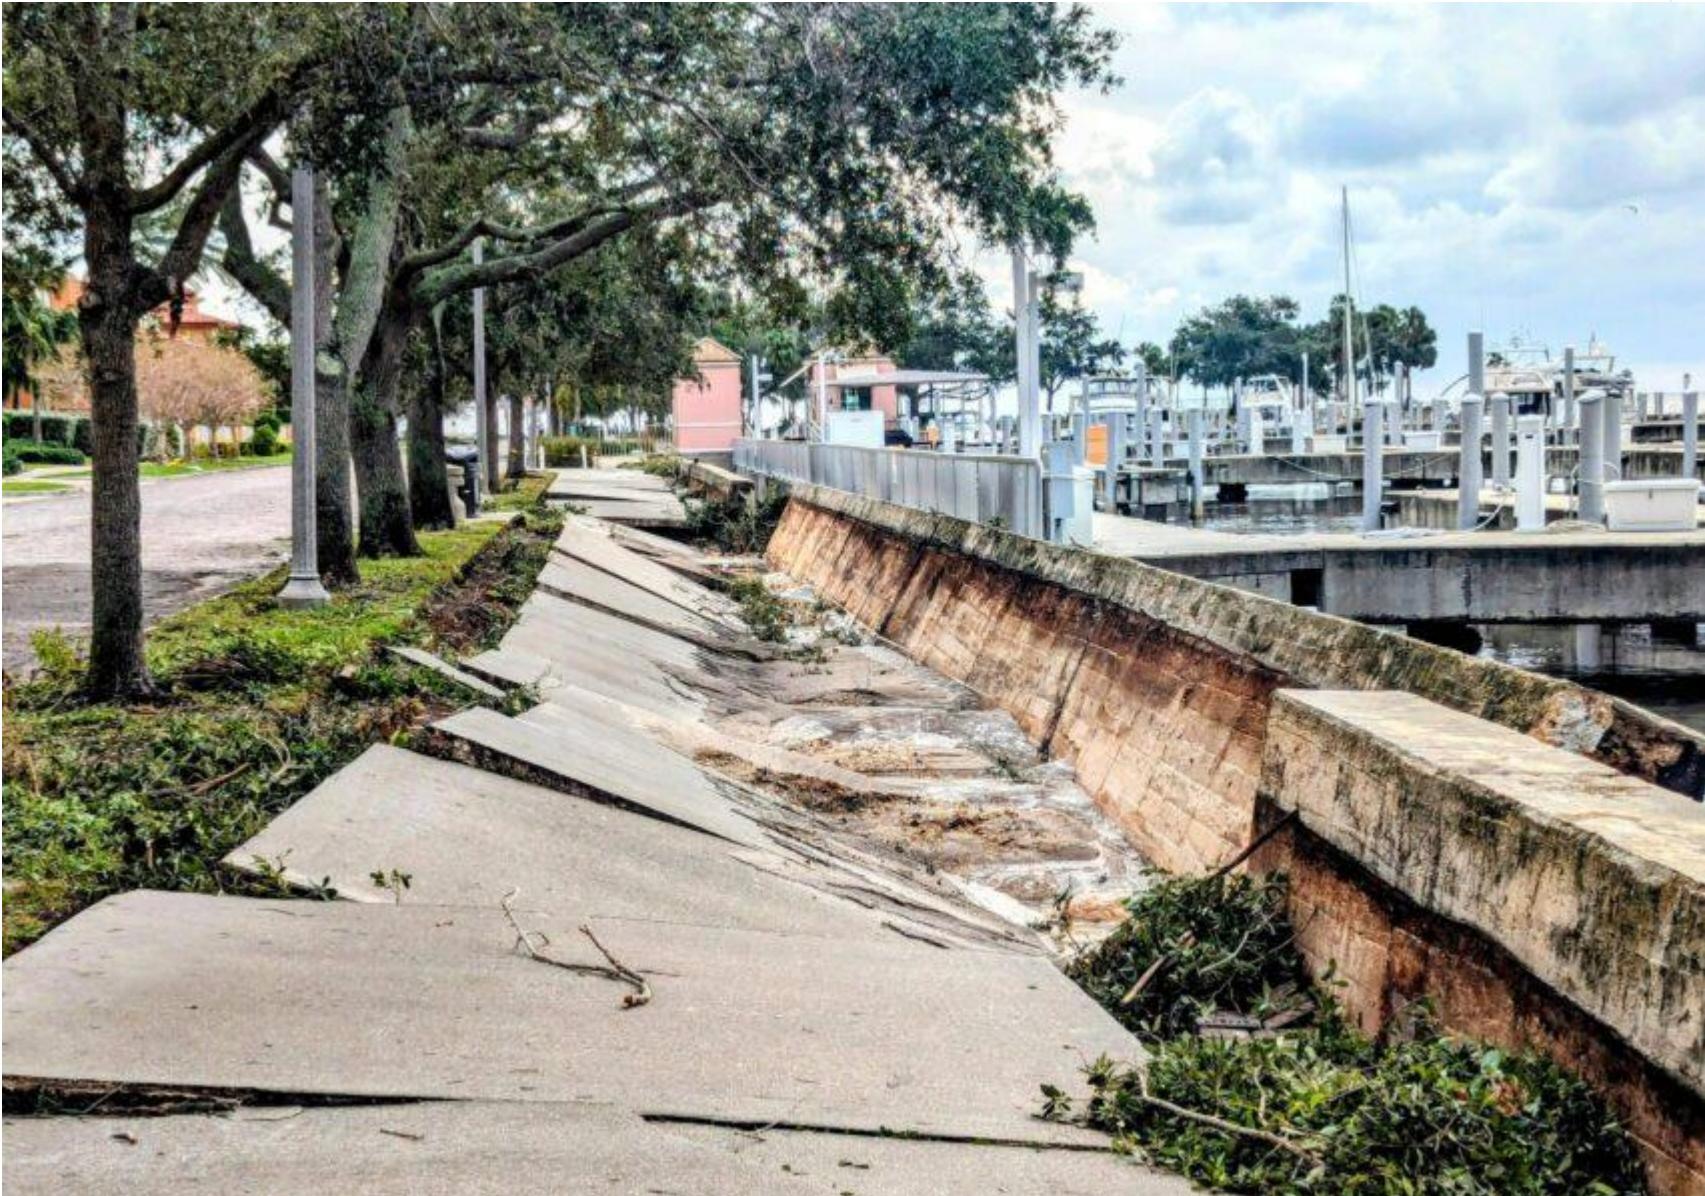
Storm Surge Vulnerability – Helene

- Category 4 hurricane at landfall in Perry, FL
- Helene moved quickly at 23mph
- Eye of the storm approx. 170 miles south-southwest of Tampa
- St. Petersburg NOAA station peak surge = +7.09 feet NAVD (per FEMA FIS is between a 25-year and 50-year return period storm)

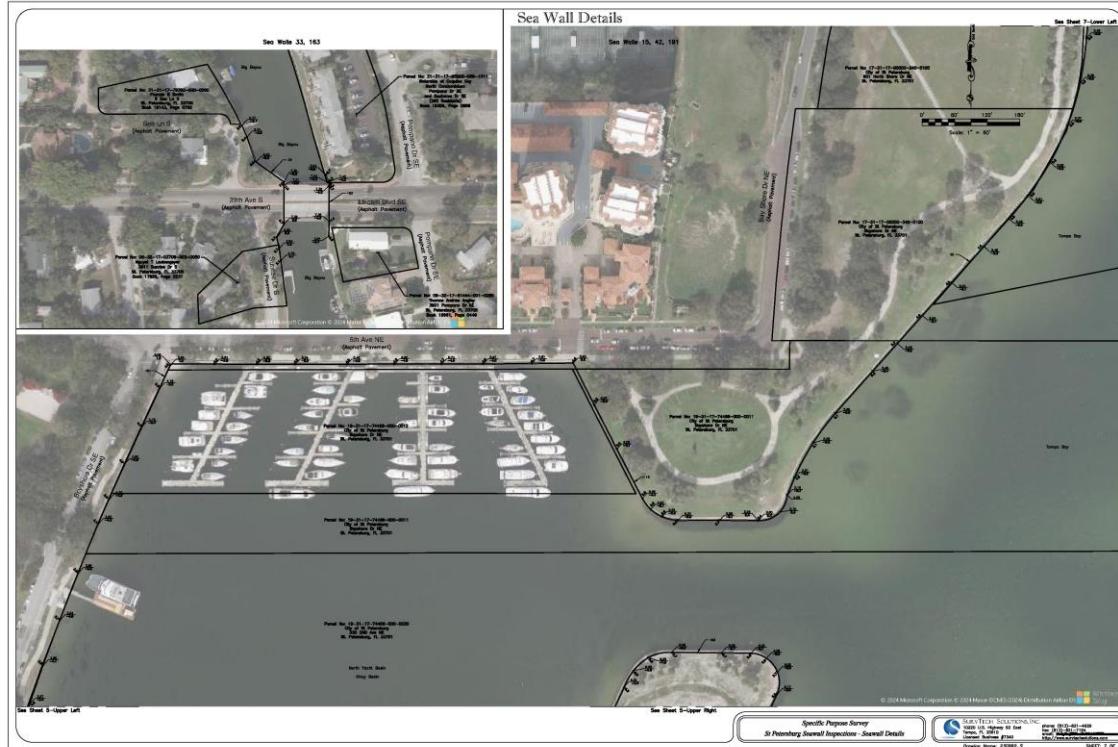
Seawall Elevation Summary

Cap Elevation (ft-NAVD)	Length of Wall (LF)	% of Total Length
< +2.0 ft	1,270	2%
+2.0 to +3.0 ft	9,371	13%
+3.0 to 4.0 ft	19,816	28%
+4.0 to 5.0 ft	12,920	18%
> +5.0 ft	24,156	34%

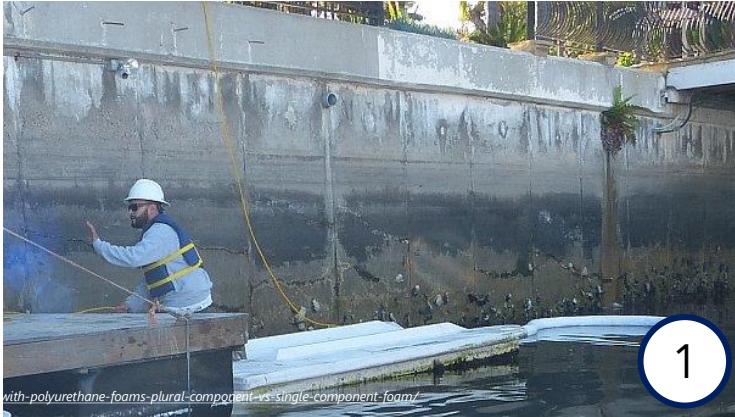
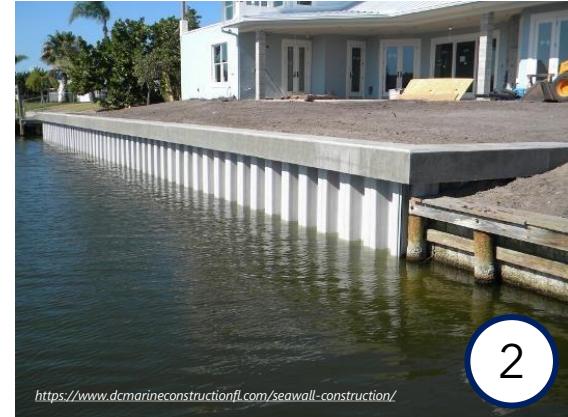
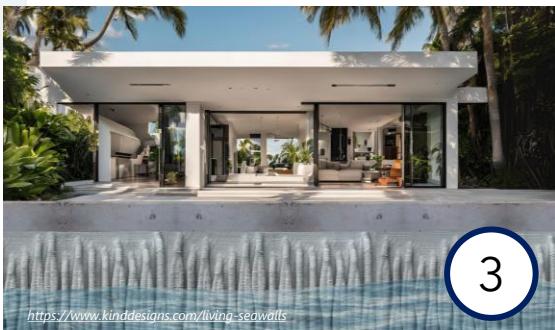
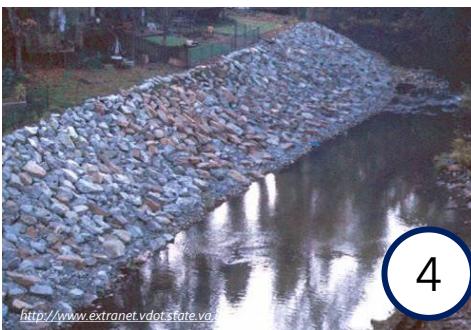
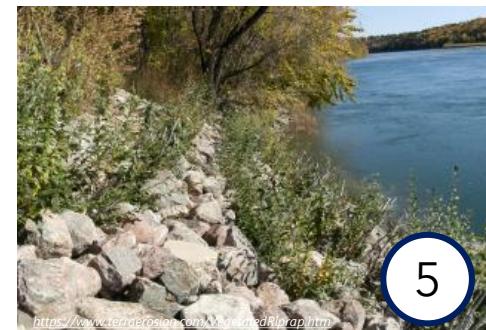
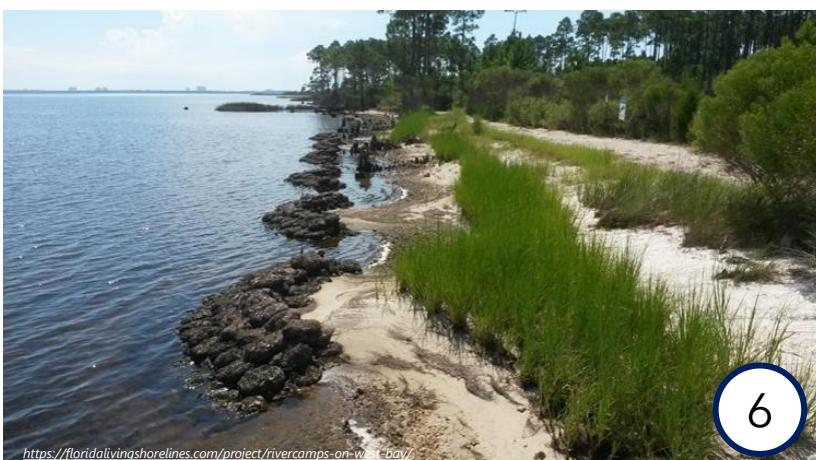
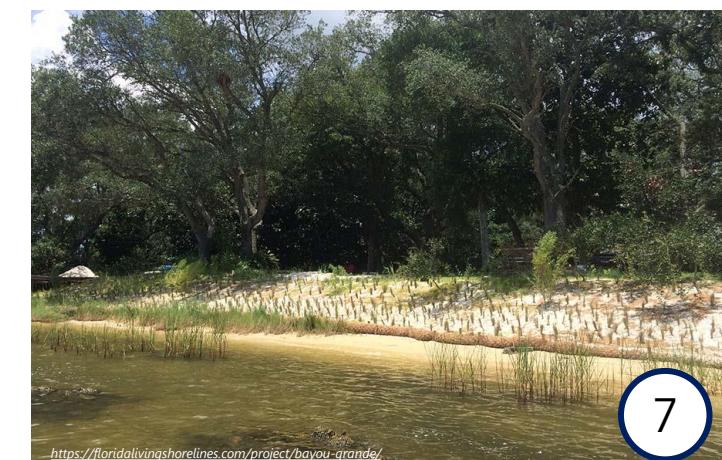
Coastal Toolbox

Categories		Description
1	Repair only	Wall rating of Fair or better. Adequate remaining service life (10 yrs<)
2	Replace in-kind, raise cap elevation	Where space is a constraint. Wall rating of Poor or less
3	Environmental enhancement	Living panels, oyster domes, toe rock, upland planting/swale
4	Rock revetment/planters	Replacement of vertical walls to include vegetation while maintaining smaller footprint
5	Hybrid shoreline (Alternative 1)	Rock sill/vegetated slope/ planters
6	Hybrid shoreline (Alternative 2)	Rock breakwater/pocket beaches/groins
7	Natural living shoreline	Vegetative plantings

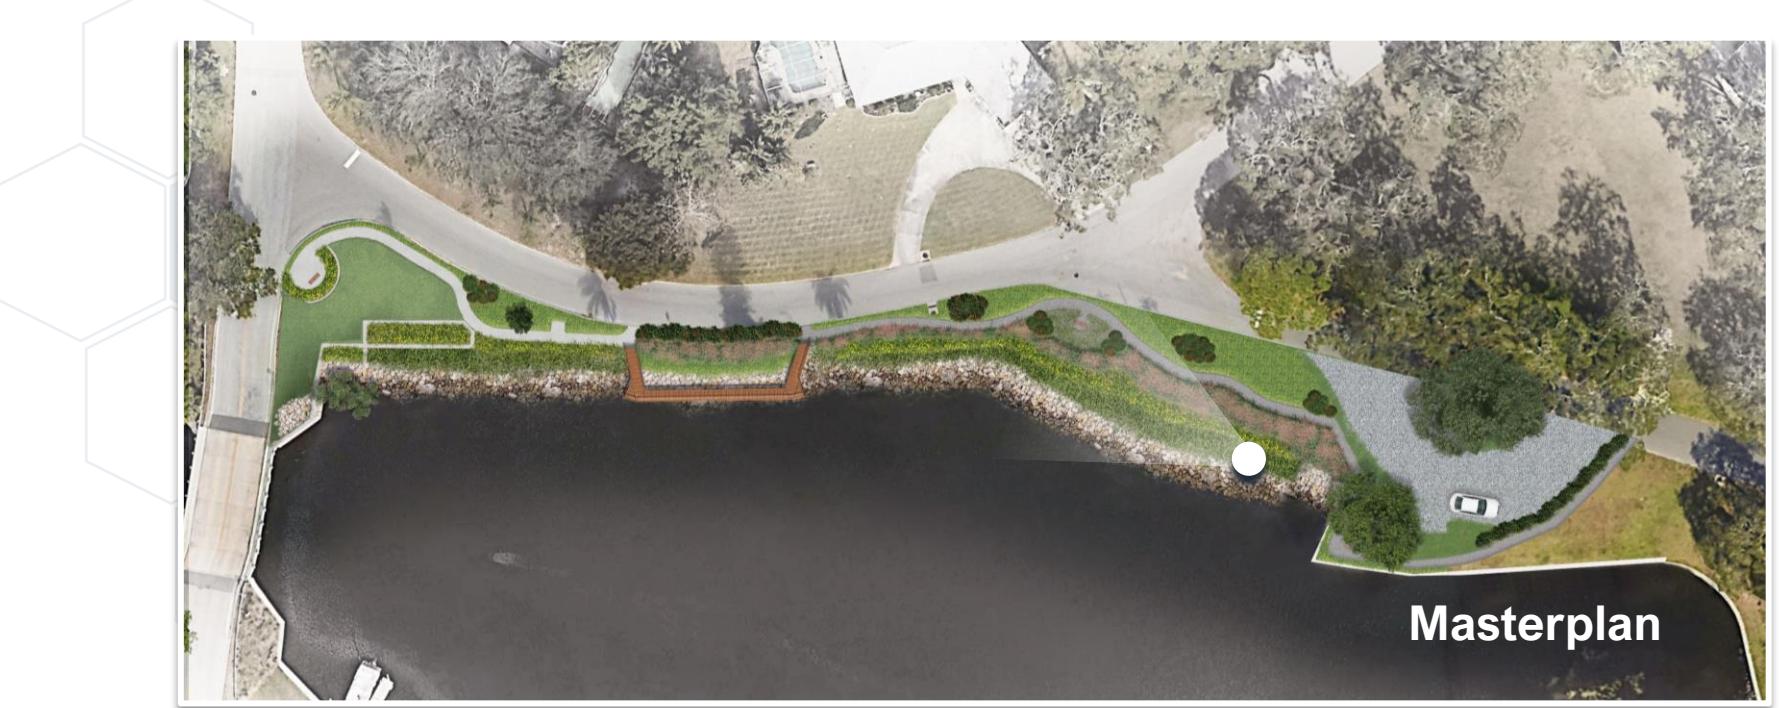
Conceptual Render

- Connects to Palma Sola Bay in Bradenton
- Existing concrete weir
- 1960's era deteriorating bulkhead
- Relatively low energy in basin
- Project goals Combines:
 - Remove existing wall to create more natural shoreline
 - Enhance recreational use of park
 - Boardwalk, pathway
 - Native vegetation, oyster domes
- Stakeholder engagement
