Facilitating Cohesion in Stormwater Maintenance

*A Single Asset, an Entire State, and
Everything in Between*

Maintenance Guide for Stormwater Assets

Office of Maintenance

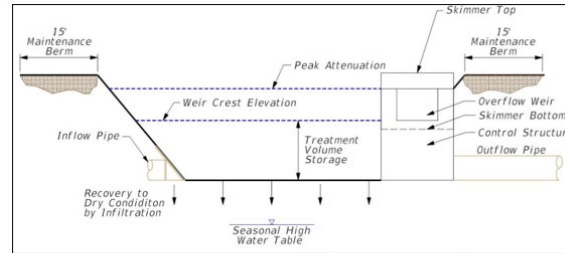
Figure 4-19. Typical Dry Retention System Schematic (Not to scale) [Return to List of Figures](#)

Dry retention systems are storage areas designed to temporarily store a defined quantity of stormwater runoff, gradually recovering its storage capacity by infiltrating stormwater through the pond bottom to the surficial groundwater aquifer and evaporating water to the atmosphere (Figure 4-19). After drawdown of the stored runoff is completed, the basin does not hold any water, thus the system is dry under normal conditions.

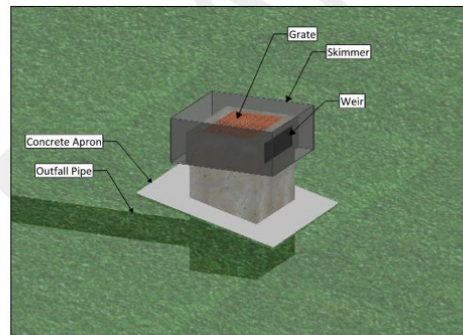
Figure 4-20. Typical Dry Retention Pond Control Structure – Isometric View (Not to scale) [Return to List of Figures](#)

1. An emergency overflow structure that does not include a drawdown device (i.e., orifice or weir notch) since the treatment volume should be recovered through percolation through the pond bottom (Figure 4-20 and Figure 4-21).

3. A grate located at the top of the emergency overflow structure serves as the emergency outfall for a dry retention system. If an emergency overflow structure is not provided, an emergency spillway will be installed in the pond bank to provide flood protection.

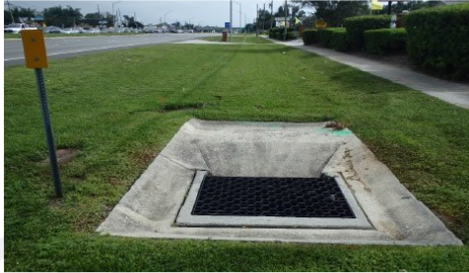
A **Treatment Swale with Control Structure, with or without Filtration** is a dry retention system with an emergency overflow control structure. The elevation of the outfall control structure determines the depth of retention and treatment volume of the swale. The dry retention area is often underlain with perforated drainage pipe that collects and conveys percolated stormwater to the control structure. Underdrain systems are intended to control the groundwater table elevation over the entire area of the treatment basin and provide for the drawdown of the treatment volume. Cleanout ports are provided for maintenance of the filtration system.

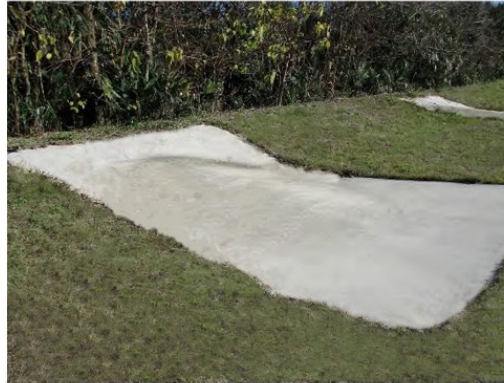
In a **Concrete Ditch Block** system, the ditch block structures are overlain by a layer of concrete. These are retention systems that are designed to hold water during typical storm conditions. During more severe storms, water may discharge over the top of the concrete berm.

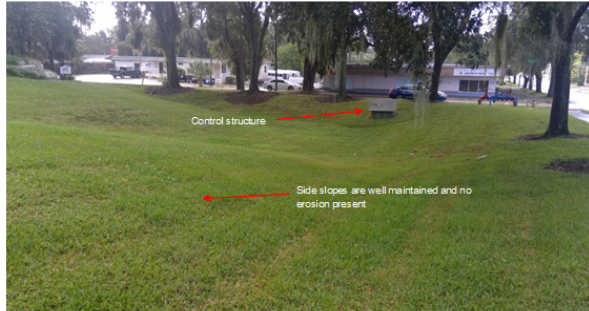
A-27

Good Erosion Condition

Dry Pond

- Control Structures – Good
 - No visible damage
 - Free of vegetation growth
- Aesthetic Condition – Good
 - No debris or trash present
 - Side slopes are well maintained
- Erosion Condition – Good
 - No slope erosion or fills observed
- Hydraulic Recovery – Good
 - System dry, indicating the system is recovering its treatment volume
- Sedimentation – Good
 - No evidence of sedimentation problems observed
- Vegetation Condition – Good
 - Vegetation cover intact, with no bare areas
 - Pond is mowed regularly

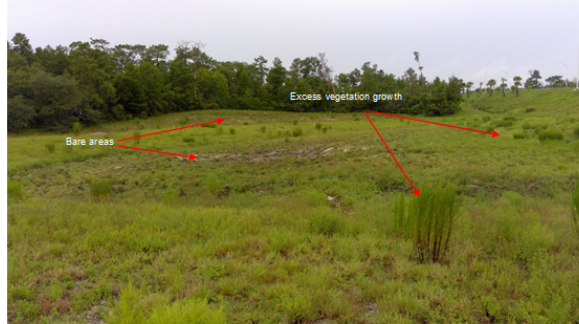
A-18

Fair Erosion Condition

Dry Pond

- Aesthetic Condition – Fair
 - Bare areas on side slopes and within pond
 - No debris or trash present
- Erosion Condition – Fair
 - Areas of bare soil observed within the pond and along the side slopes
- Hydraulic Recovery – Good
 - System dry, indicating the system is properly recovering
- Sedimentation – Good
 - No evidence of sedimentation problems observed.
- Vegetation Condition – Fair
 - Excessive vegetation growth observed within the pond bottom and along the side slopes

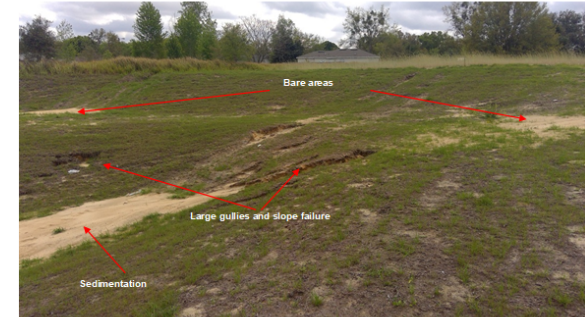
A-35

Poor Erosion Condition

Dry Pond

- Aesthetic Condition – Poor
 - Side slopes not well maintained
- Erosion Condition – Poor
 - Substantial erosion present
 - Large gullies present along slope
 - Slope stability compromised
- Hydraulic Recovery – Good
 - System dry, indicating the system is recovering its treatment volume
- Sedimentation – Fair
 - Sedimentation to pond bottom from slope erosion
- Vegetation Condition – Poor
 - Vegetative cover poor, with bare areas present

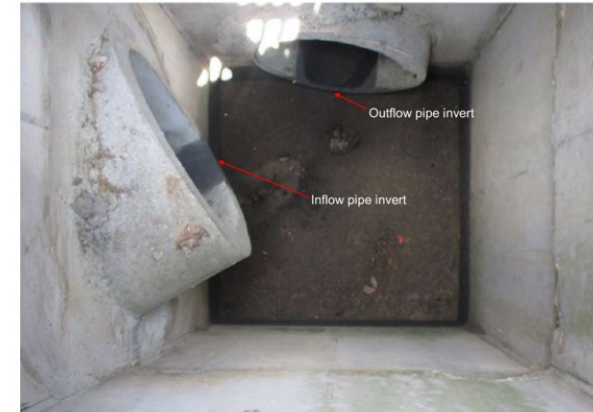
C-1

Horizontal French Drain System

- Sump – Good
 - Free of trash and debris
 - No cracks or damage
 - No sign of groundwater intrusion
- Pipes – Good
 - No cracks or obstructions
- Hydraulic Recovery – Good
 - Sump is dry, indicating proper drainage and recovery
- Sedimentation – Good
 - No sediment observed

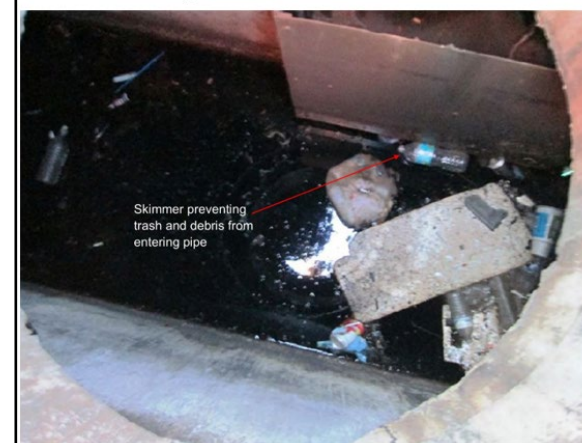
C-4

Horizontal French Drain System

- Sump – Fair
 - Some trash and debris are present
 - No visible cracks or indication of groundwater intrusion
- Skimmer – Good
 - No damage to skimmer
 - Skimmer is effectively preventing trash from entering pipe
- Hydraulic Recovery – Fair
 - Partial blockage of skimmer is slowing system recovery

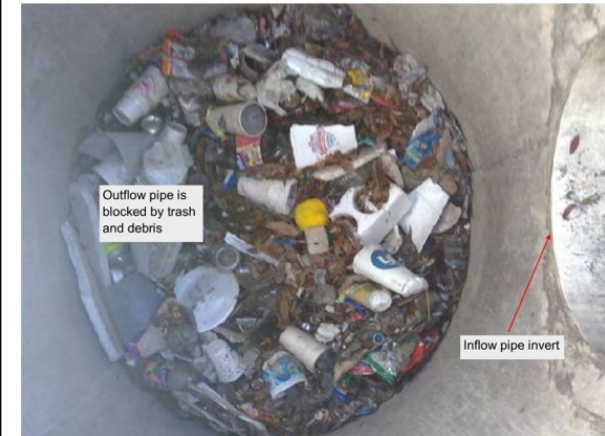
C-3

Horizontal French Drain System

- Sump – Poor
 - Trash and debris are covering outflow pipe
- Pipes – Poor
 - Outflow pipe is 100 percent obstructed
- Hydraulic Recovery – Poor
 - Obstruction of outflow pipe is affecting system recovery

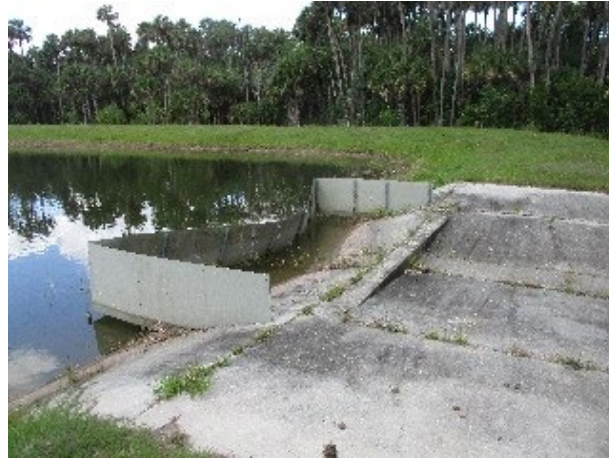
Photo Name : 2.JPG

Inspection Date:	5/10/2022	State Road Number:	46
Statewide Facility ID:	D5SWF77000-00469	County:	SEMINOLE
District Facility ID:	77040-3521-01	Facility Type:	Wet Detention
FM Number:	240163	Facility Name:	Pond 1

Maintenance Need:	MMS Code (Not Required)	Date Ordered	Date Due	Date Completed
Repair damaged skimmer on the control structure for Pond 1.		5/10/2022	7/11/2022	Not Completed
